UNITED STATES DISTRICT COURT WESTERN DISTRICT OF TEXAS AUSTIN DIVISION

COMPLAINT

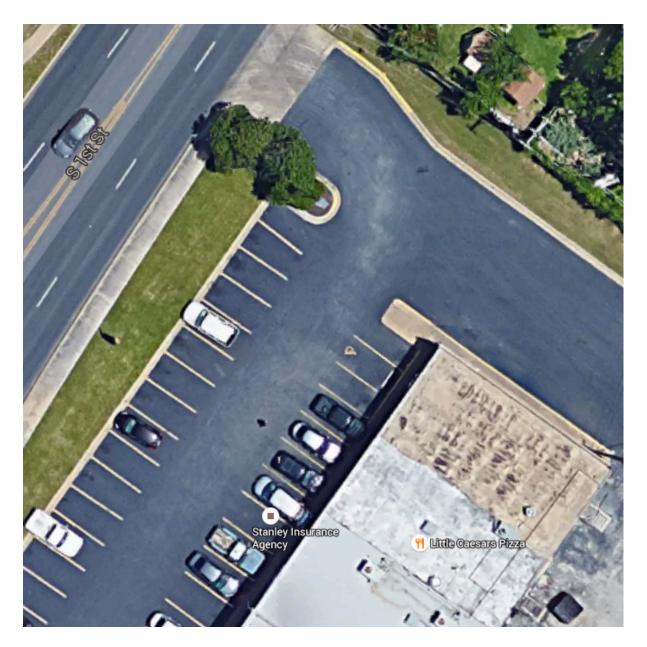
Fig. 1 - Overhead view of CAPITOL CLEANERS IN 2015.

Satellite Images from *Texas General Land Office, Texas Orthoimagery Program, U.S. Geological Survey, 2015.* Note: Zero ADA-Compliant Van Accessible Parking Spaces are Visible (96" Wide with 96" Side Access Aisle). Under the Americans with Disabilities Act, this location must have <u>one</u> ADA-Compliant Van Accessible space (96" Wide with 96"Side Access Aisle).

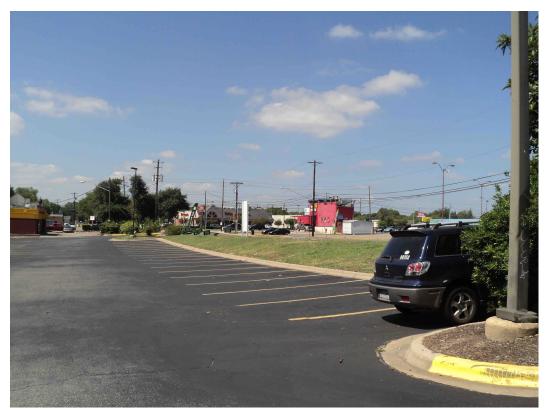
Fig. 6 – Wide Angle View of West Parking Lot. Note: Not ADA-Compliant. No Disabled Parking.

Fig. 7 – Northeast Side of Building. No Disabled Parking.
